MIDGET MUSTANG - MODEL M-I

MANUAL REVISIONS

## Mustang II & Midget Mustang Service Letter

Subject: Inspection of the tailcone transverse bulkhead p/n 240.345 (M-II)  
or p/n 140.356 (M-I)

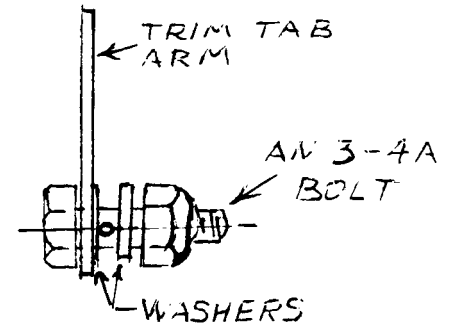
DWG. NO. 36 - TRIM TAB: CONTROL WIRE ATTACHMENT.

The .062 dia. hole drilled in the AN3-4A bolt for attaching the trim control wire is to be located .125" from the bolt head. The trim tab control arm is located between the bolt head and the wire. The control arm must be free to swivel without binding. A AN960-311 or 316L washer may be used to reduce excessive play of the arm. A AN960-316 washer and AN365-1032 nut are used to complete the installation. The nut is drawn tight to secure the control wire.

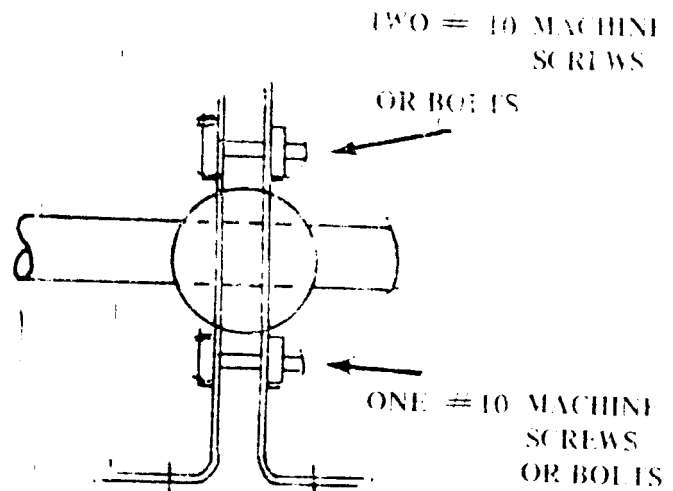
DWG. NO. 33 - AILERON TORQUE TUBE INBOARD MOUNT.

A builder suggested alternate method of mounting the aileron control torque tube at the fuselage end. (Ref. dwg.33) This method uses a MOONEY aircraft part which is a micarta ball of aprox. 1½" O.D. with a ¾" dia. center bore. The micarta ball is mounted by means of two simple angle brackets three in. long fabricated of .040 al. with a 1" dia. hole for mounting the ball. On installation the micarta ball is self aligning on the tube. Tightening the 3 clamping bolts makes this a rigid installation.

The micarta balls are available from BUSHBY AIRCRAFT INC.

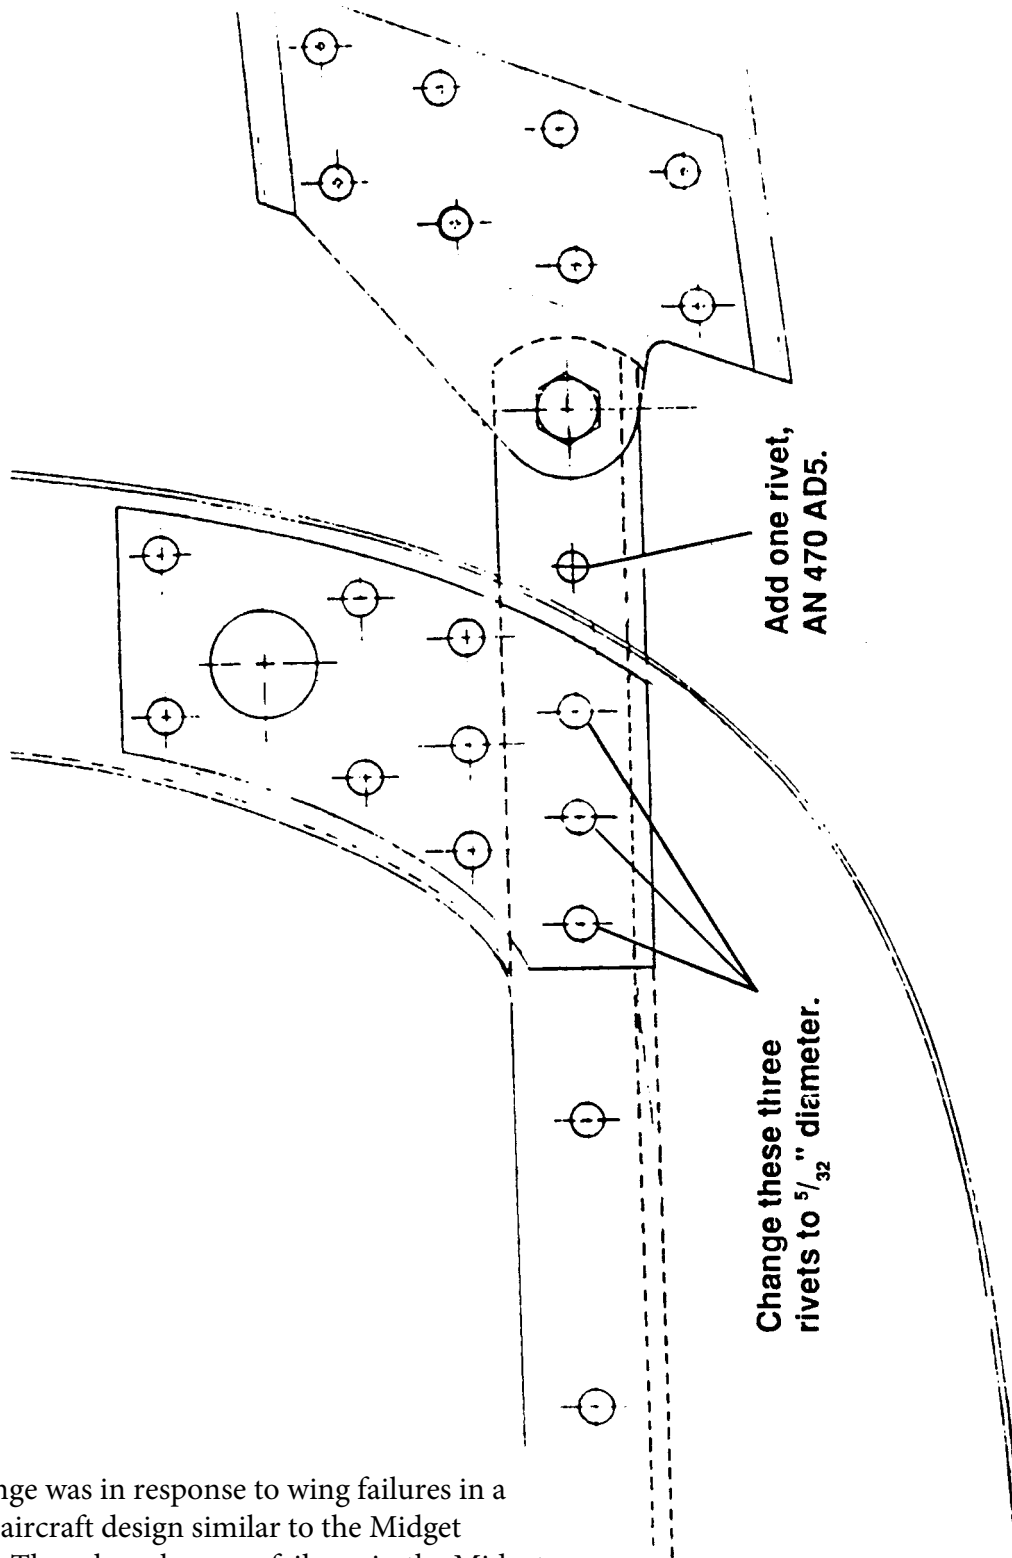
**Midget Mustang Station 99.35 Revision**  
**Left side shown. Modify both sides.**  
*Detail from drawing No. 9*

This change was in response to wing failures in a different aircraft design similar to the Midget Mustang. There have been no failures in the Midget Mustang but proper edge distance of the wing rear spar attach bolt should be verified. If flown within given weight limits and built per specs this change would not need to be made to existing aircraft as more harm may be done than good.

Add reinforcement of 0.063 2024-T3 aluminum, 1 inch wide by 24 inches long. Position the reinforcement between the bulkhead and the carry-through angle. Change the three outboard rivets to AN 470 AD5 rivets. Add an additional rivet as shown.

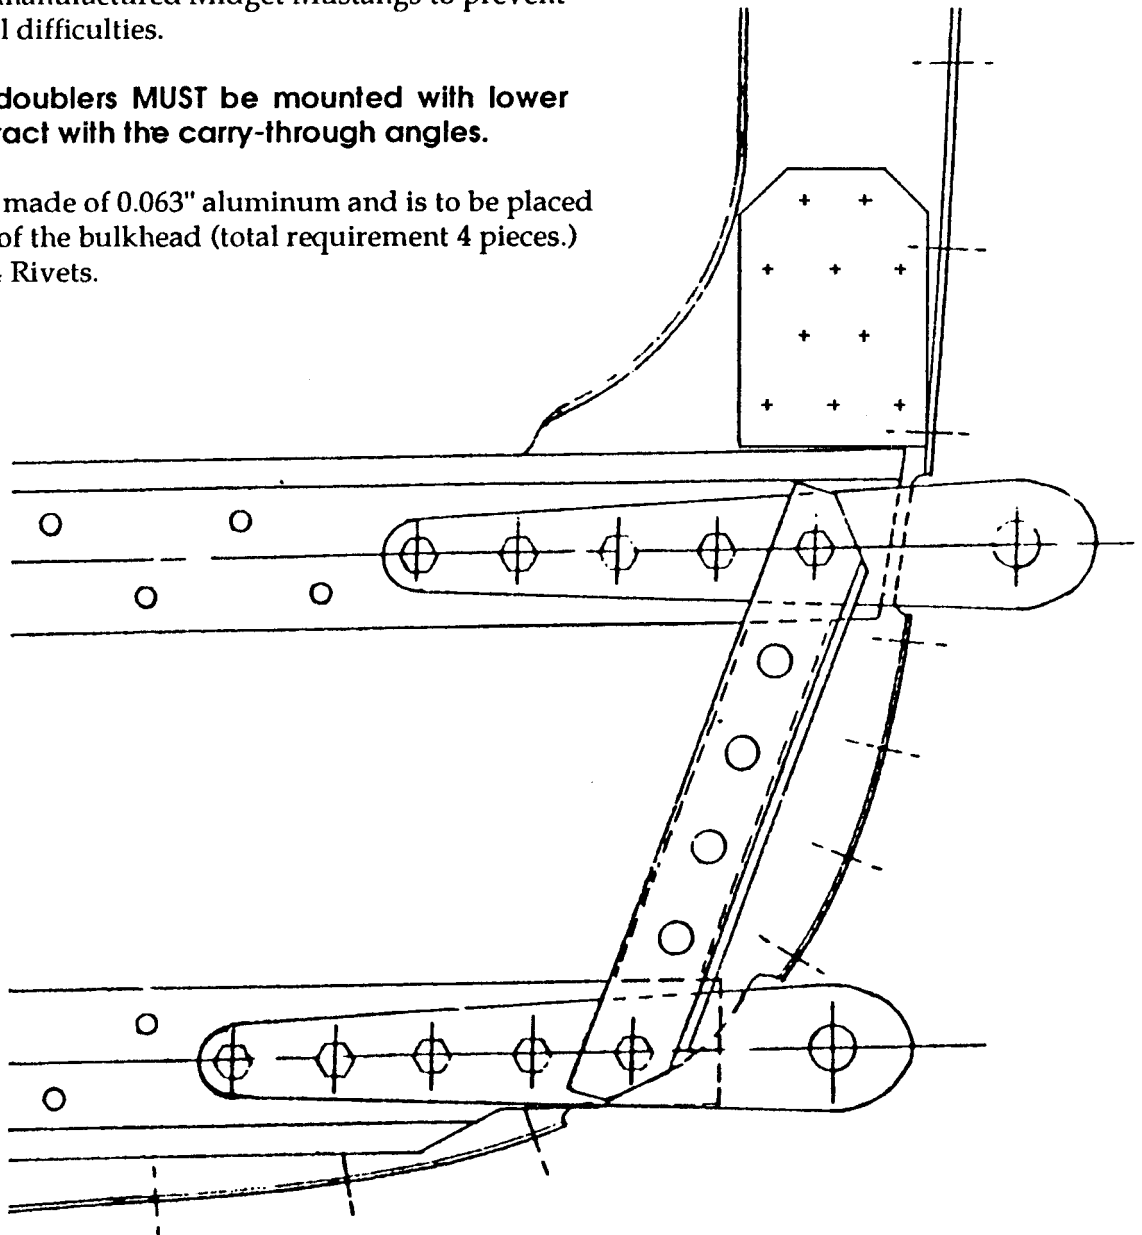
Station 73.75 Bulkhead

There are reports from the field of cracks developing in the station 73.75 bulkhead. The crack starts at the top outboard corner of the angle carry-through member, emanating from the cut out for the wing fitting clearance. Examination of this area may also show a bulge in the bulkhead web. It is suspected that the crack and bulge is caused by high inertial loads created by high "G" landings.

Installation of the doublers shown in the illustration would be a satisfactory repair. Installation of the doublers is recommended for new manufactured Midget Mustangs to prevent future operational difficulties.

**NOTE: The doublers MUST be mounted with lower edge in contact with the carry-through angles.**

The doubler is made of 0.063" aluminum and is to be placed both fore and aft of the bulkhead (total requirement 4 pieces.) Use AN 470 AD 4 Rivets.

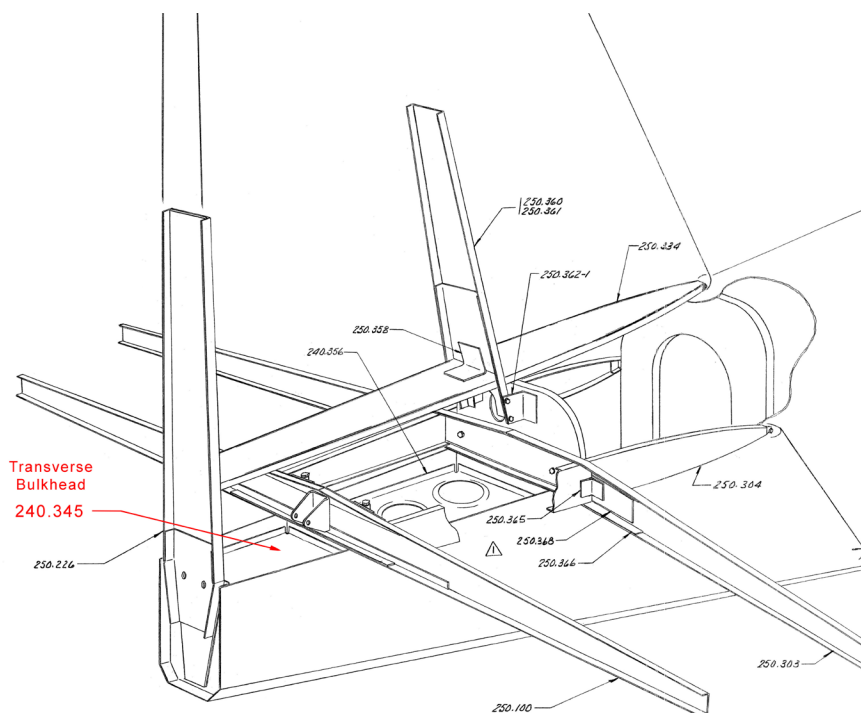
The small Transverse Bulkhead is a critical attach point for the vertical fin as it has 2 of the 3 lower fin rear spar attach points. Refer to construction drawing #29 for the Midget Mustang and drawings 240.021 and 240.023 for the Mustang II.

The affected aircraft suffered a fatigue crack in the transverse bulkhead emanating from the aft two corners whose flange is attached to the sta 209.5 bulkhead in the Mustang II. In the Midget Mustang the affected Transverse Bulkhead flange attaches to the sta. 182 bulkhead. Previously issued updates and repeated inspection recommendations have not always been adhered to. Improper manual ground handling has been the primary cause of the failures that we have seen. The original design is sound if the aircraft is not subjected to unapproved/nonstandard loads.

Repeatedly moving the aircraft on the ground by lifting the tail of the airplane by the horizontal stabilizer or applying a side load to the vertical fin can put excessive torsional loads on the Transverse Bulkhead. Mustangs should never be lifted or moved by applying force to the empennage. Instead steer the airplane manually on the ground by pushing on the side of the tailcone at a bulkhead, by lifting the tailwheel and pulling the airplane around by it, or by a tow bar connected to the tailwheel or nose wheel. Snap rolls can also put excessive loads on the transverse bulkhead. If aerobatics are performed in aircraft without the updates the aft tailcone inspection cover should be removed and the transverse bulkhead inspected more than once per year. Snap rolls are not approved in the Mustang II. Proper installation of the 3 AN3 bottom fin rear spar attach bolts is also critical.

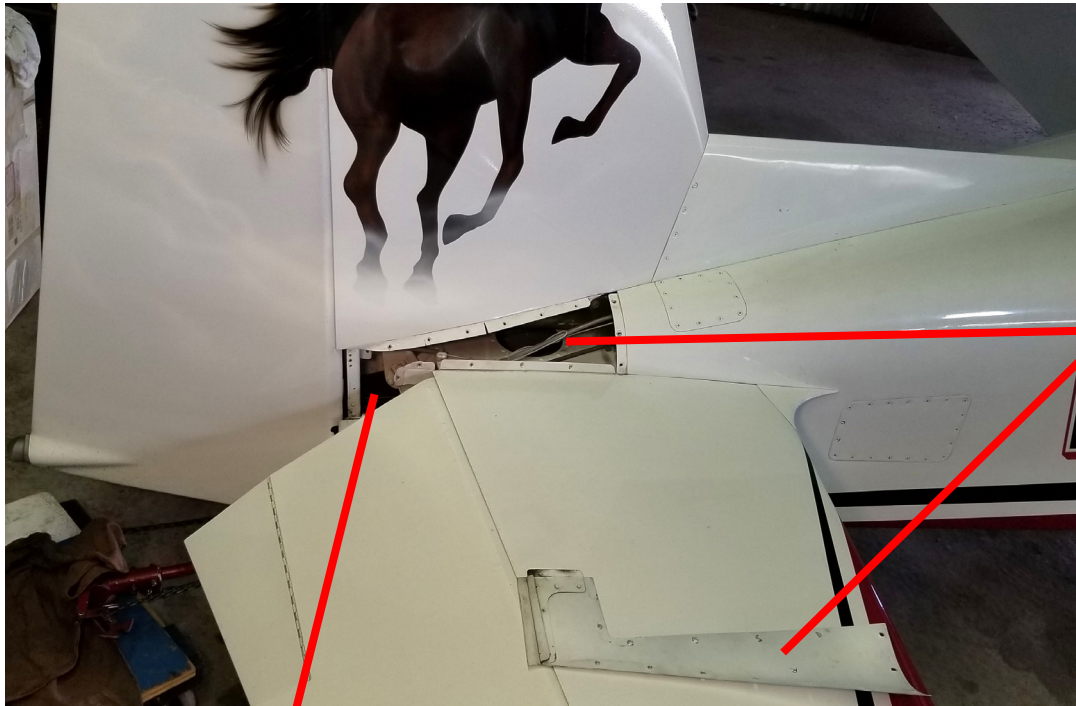
Aft Tailcone  
Inspection Cover

Transverse Bulkhead

During the annual airworthiness inspection and more often as needed, the aft transverse bulkhead should be visually inspected by removing both of the aft tailcone covers between the vertical fin and horizontal stabilizer. A close examination of the transverse bulkhead (p/n 240.345 / 140.356) for any cracks and the steel elevator control arms (p/n 250.210 / 150.210) for cracks around the welds is an important part of every airworthiness inspection.

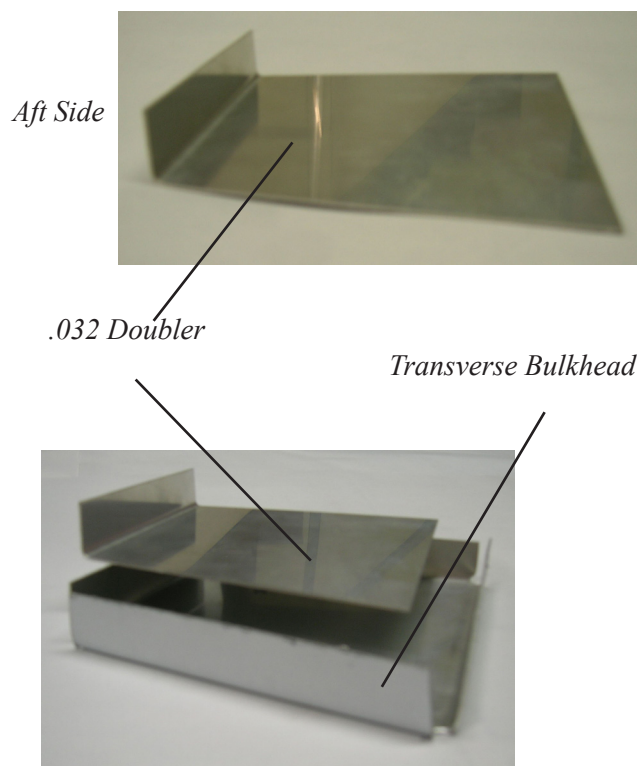
## Transverse Bulkhead Doubler

We had a report that a Mustang II had a failure in the Transverse Bulkhead p/n 240.345 although this was probably the result of a missing bolt from the lower fin attach point. In a previous revision this bulkhead had been changed to thicker material and the lightening hole eliminated. This particular airplane has over 1200 hours and does not have this revision. For new airplanes we are adding an additional doubler just as an extra precaution. This is not a mandatory change. A good preflight should include checking the stiffness between the fin and horizontal stabilizer. Excessive movement is an indication that there is a problem.

For the Mustang II a lightening hole can be cut in the center of the new doubler to allow it to lay flat against the transverse bulkhead. The doubler is riveted to the bulkhead at the corners using 3/32" universal head rivets on 5/8" spacing, staggering rows 1/2" apart.

If you are building a Midget Mustang or do not have the stiffening bead in the bulkhead, the doubler can be attached to the bulkhead without the hole using 1/8" rivets on 7/8" spacing, staggering rows 5/8" apart.
