Mustang II Revisions

The following pages contain major design changes to the Mustang II.

Mustang II Revision Changes

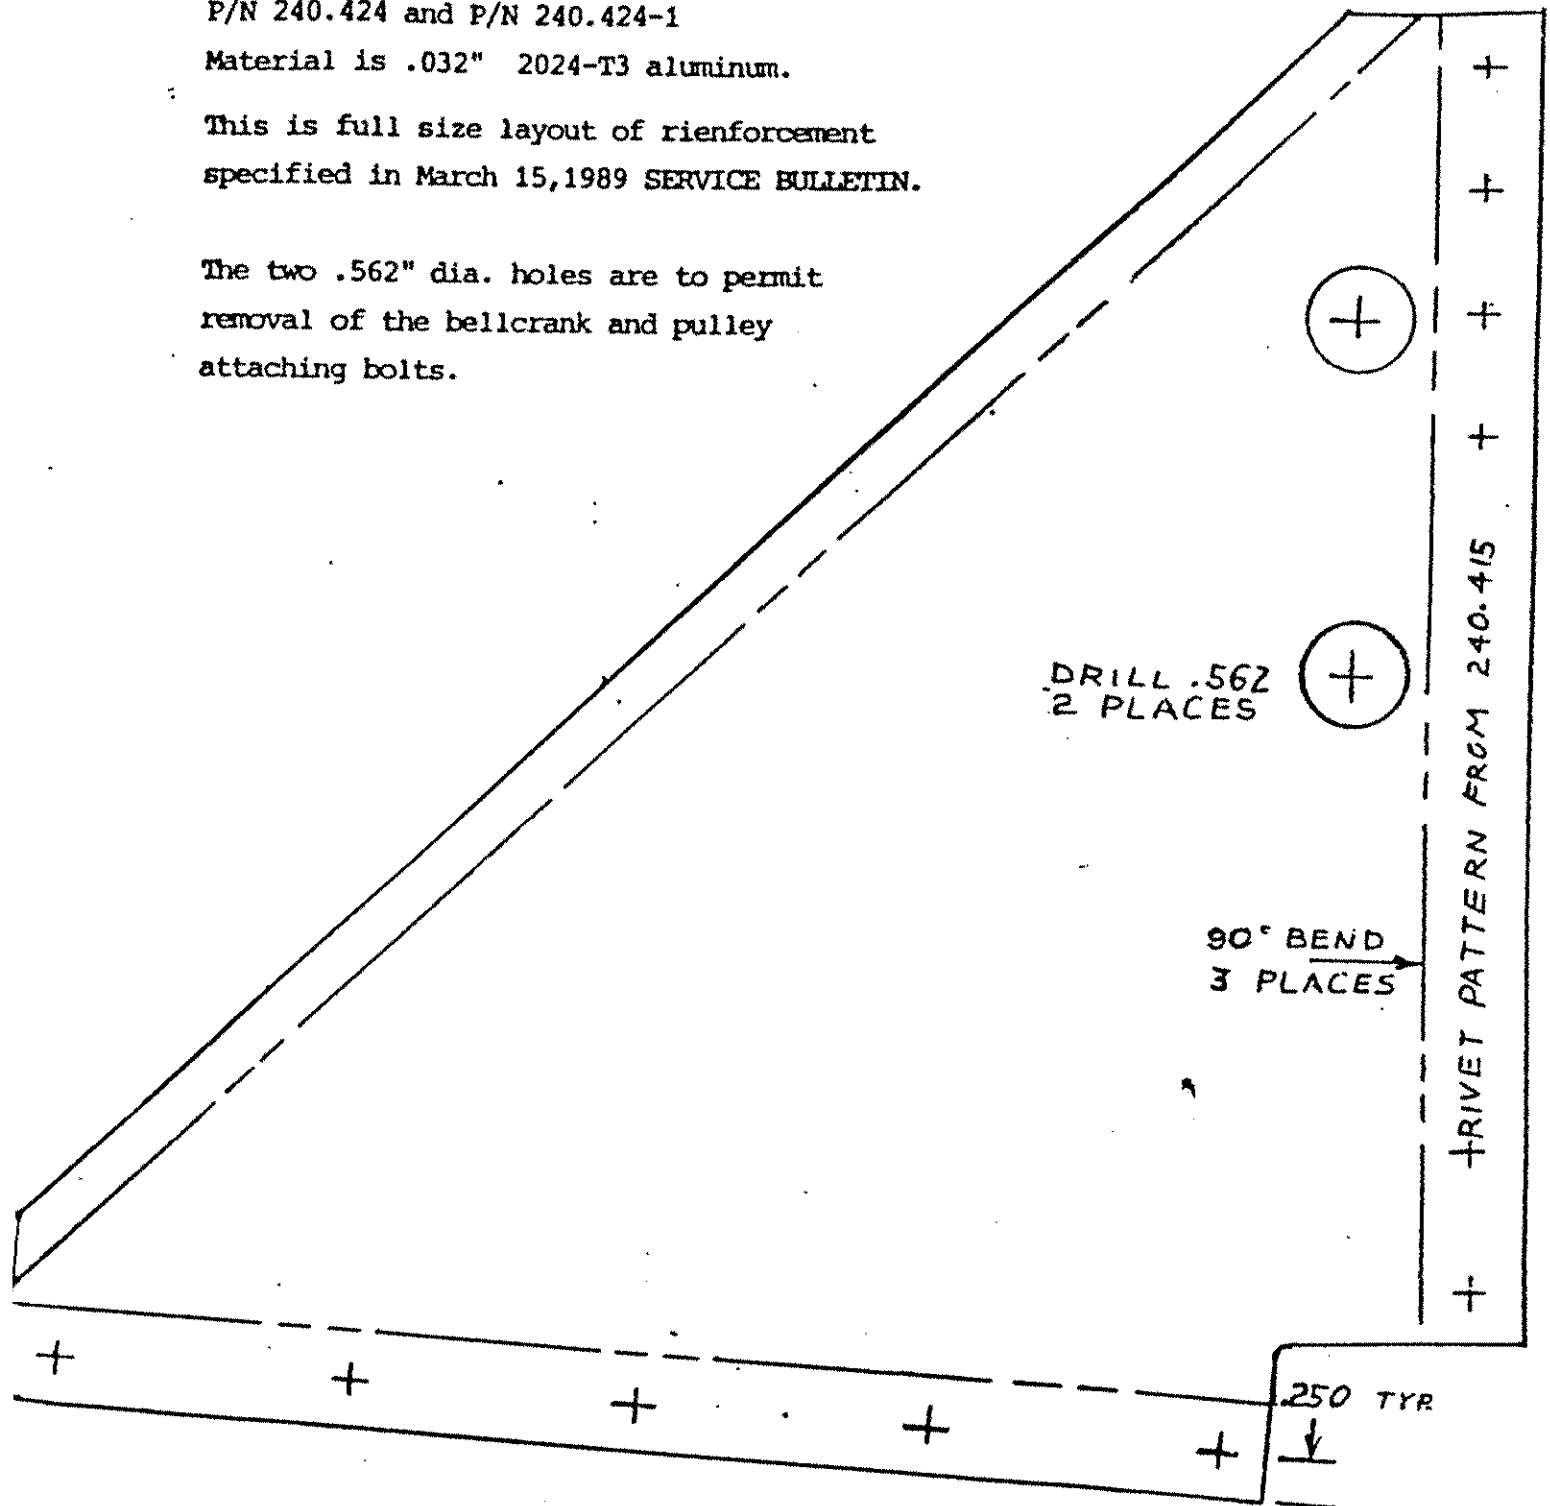
P/N 240.424 and P/N 240.424-1

This is full size layout of reinforcement specified in March 15, 1989 SERVICE BULLETIN.

The two .562" dia. holes are to permit removal of the bellcrank and pulley attaching bolts.

These reinforcements are located aft of station 114.75 with flanges facing away from aircraft center line. Attach reinforcements to P/N 240.415 & 240.415-1 at existing rivet locations using AN470AD4 rivets. Attach reinforcements to fuselage belly skin using AN426AD4 rivets spaced as shown.

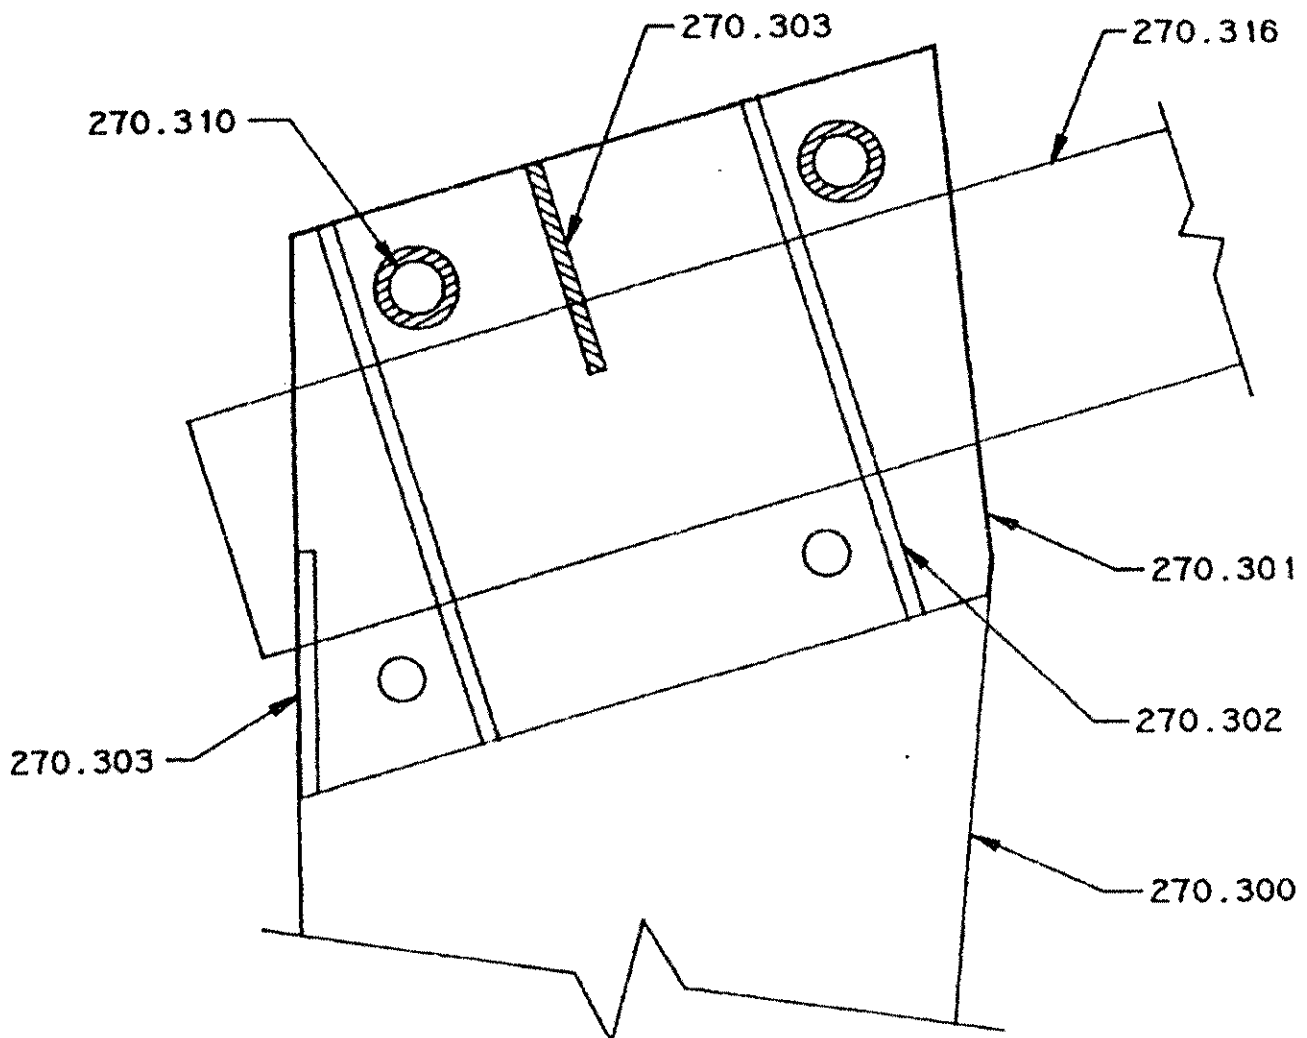
For clearance, the bushings are no longer welded to the brackets (270.302) and the 1/2" bushings have been eliminated entirely. Shorter bolts are used. The larger bushings can also be eliminated if the appropriate length bolts are used. An additional gusset has been added to provide more contact area between the plate and torque tube.

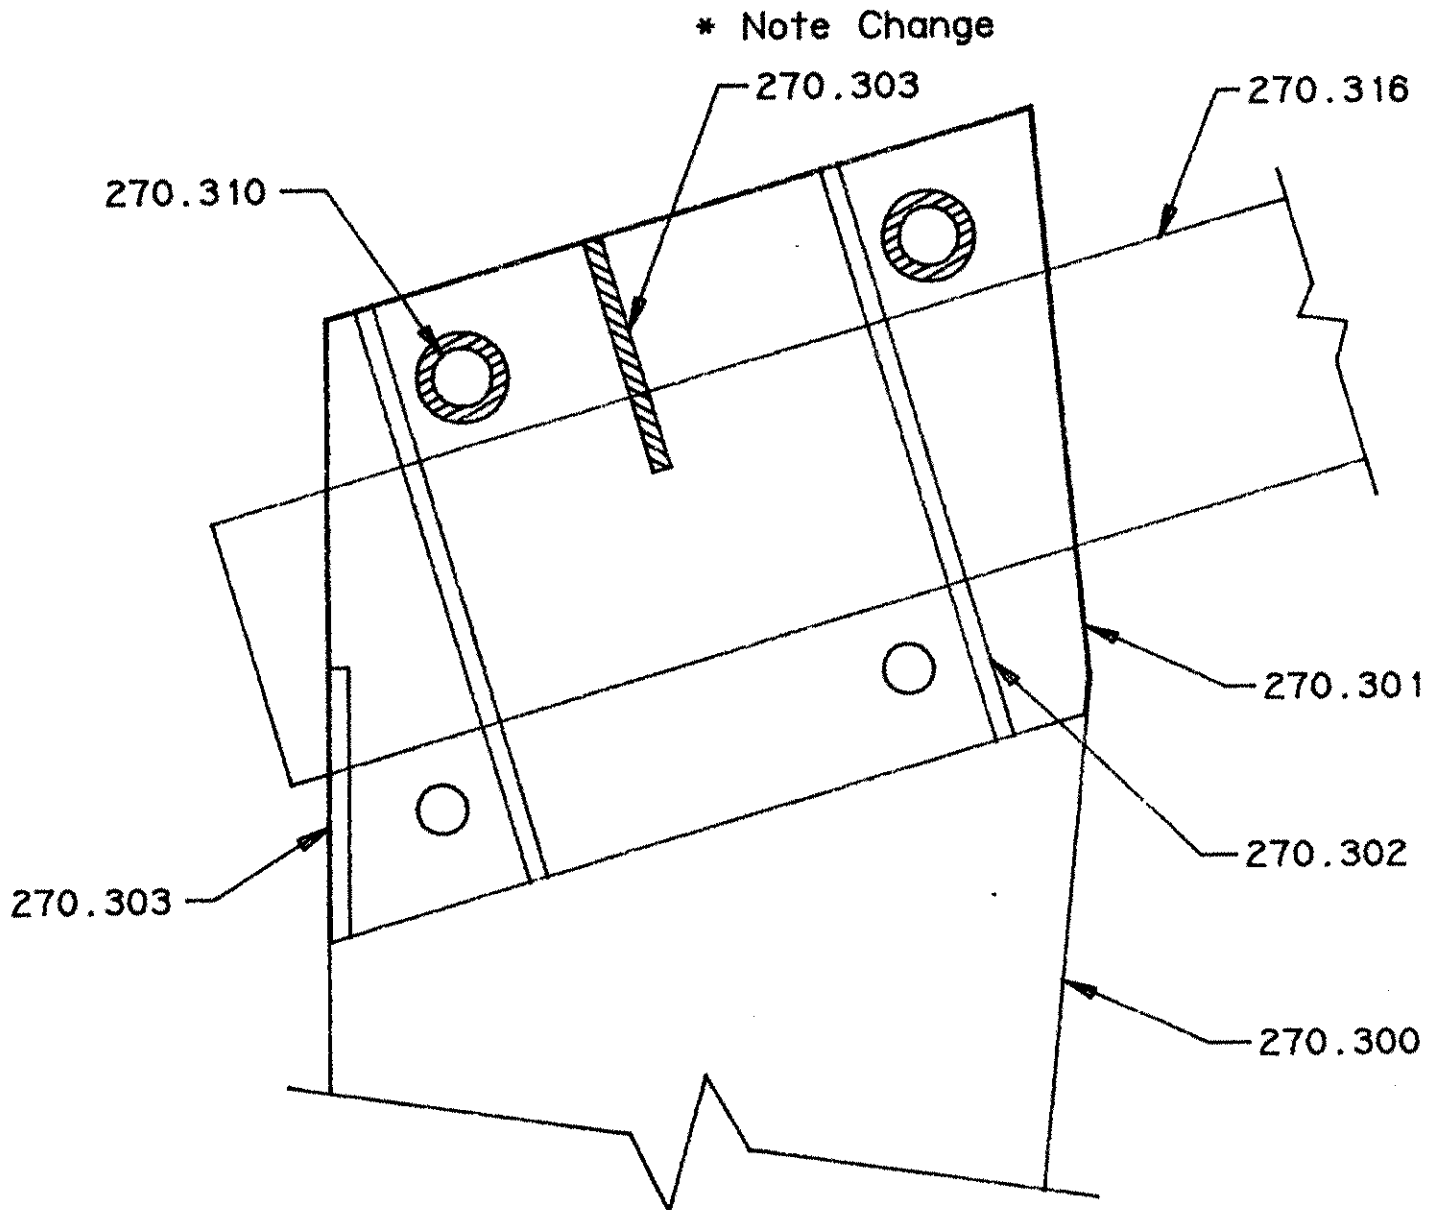
Gear Attach Plate Changes:

For clearance the bushings are no longer welded to the brackets (270.302) and the 1/2" bushings have been eliminated entirely. Shorter bolts are used. The larger bushings can also be eliminated if the appropriate length bolts are used. An additional gusset has been added to provide more contact area between the plate and torque tube.

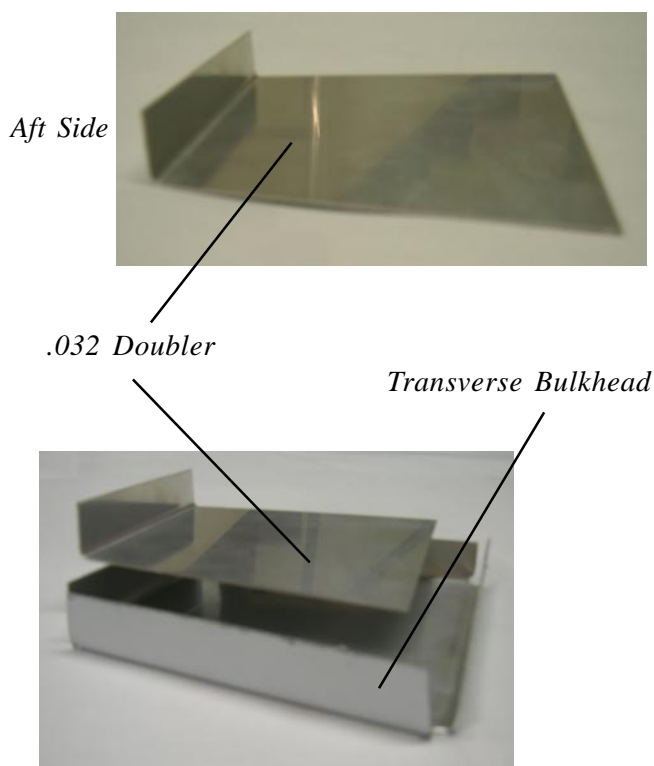
We had a report that a Mustang II had a failure in the Transverse Bulkhead p/n 240.345 although this was probably the result of a missing bolt from the lower fin attach point. In a previous revision this bulkhead had been changed to thicker material and the lightening hole eliminated. This particular airplane has over 1200 hours and does not have this revision. For new airplanes we are adding an additional doubler just as an extra precaution. This is not a mandatory change. A good preflight should include checking the stiffness between the fin and horizontal stabilizer. Excessive movement is an indication that there is a problem.

If you are building a Midget Mustang or do not have the stiffening bead in the bulkhead, the doubler can be attached to the bulkhead without the hole using 1/8" rivets on 7/8" spacing, staggering rows 5/8" apart. CAD drawings of this revision will be made available.

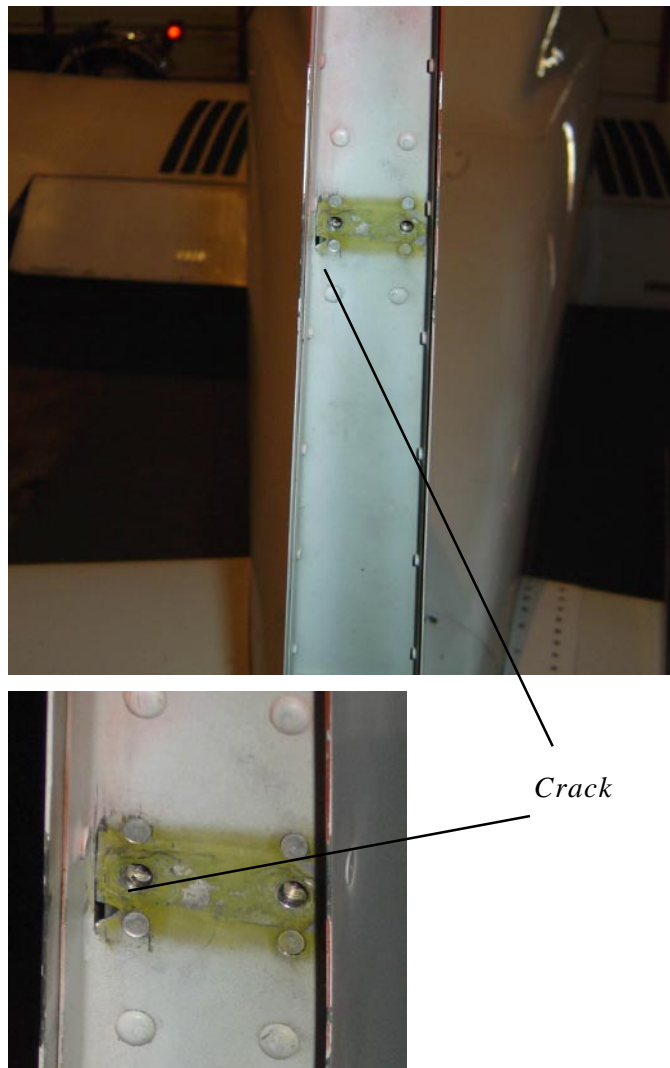
Stabilizer Hinge Bracket Advisory

Recently two Mustang II's have reported cracks around the upper fin hinge brackets. This has been covered in past newsletters. Slight binding in the hinges cause the spar to flex. Kits from Mustang Aeronautics use a different hinge design to eliminate this problem (revision is on our website). A good preflight check of the stiffness between the elevators/rudder to the fin/stab will detect any problems. The annual inspection should include a close inspection of the hinge bracket area.

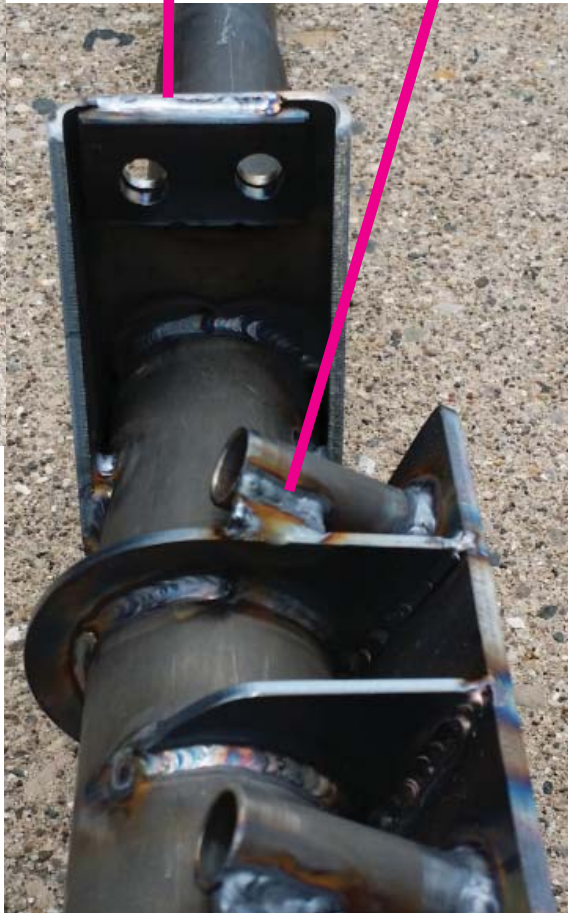
Landing Gear Mount Tube to be TIG
Welded and then Stress Relieved to a
Maximum of 1100 degrees F

Weld Down Tube Inside Bracket 0.625"
This is the CRITICAL Weld

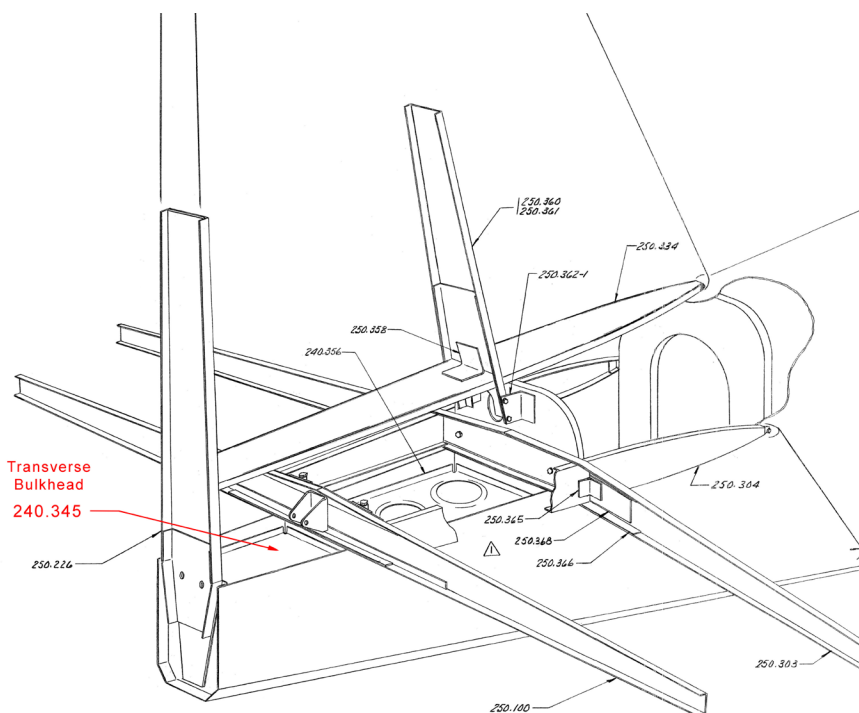
We have had another report of a failed Transverse Bulkhead (p/n 240.345) in an older Mustang II. No Mustangs with the design changes to the Transverse Bulkhead in May of 1993 have had cracking issues. The Midget Mustang has a similar design (p/n 140.356) and should follow the same inspection methods. A simple preflight check should reveal a crack in the transverse bulkhead before the aircraft is flown and should be done before every flight of all Mustangs. See page 4 for the preflight inspection procedure.

The small Transverse Bulkhead is a critical attach point for the vertical fin as it has 2 of the 3 lower fin rear spar attach points. Refer to construction drawing #29 for the Midget Mustang and drawings 240.021 and 240.023 for the Mustang II.

The affected aircraft suffered a fatigue crack in the transverse bulkhead emanating from the aft two corners whose flange is attached to the sta 209.5 bulkhead in the Mustang II. In the Midget Mustang the affected Transverse Bulkhead flange attaches to the sta. 182 bulkhead. Previously issued updates and repeated inspection recommendations have not always been adhered to. Improper manual ground handling has been the primary cause of the failures that we have seen. The original design is sound if the aircraft is not subjected to unapproved/nonstandard loads.

Repeatedly moving the aircraft on the ground by lifting the tail of the airplane by the horizontal stabilizer or applying a side load to the vertical fin can put excessive torsional loads on the Transverse Bulkhead. Mustangs should never be lifted or moved by applying force to the empennage. Instead steer the airplane manually on the ground by pushing on the side of the tailcone at a bulkhead, by lifting the tailwheel and pulling the airplane around by it, or by a tow bar connected to the tailwheel or nose wheel. Snap rolls can also put excessive loads on the transverse bulkhead. If aerobatics are performed in aircraft without the updates the aft tailcone inspection cover should be removed and the transverse bulkhead inspected more than once per year. Snap rolls are not approved in the Mustang II. Proper installation of the 3 AN3 bottom fin rear spar attach bolts is also critical.

A transverse bulkhead failure typically leaves only the vertical fin leading edge attach bolt, the single bottom lower fin rear spar attach bolt, and the rudder cables to hold the vertical fin on the aircraft. While a loss of the vertical fin has not occurred, serious structural damage has resulted from the failure of this bulkhead. In June 1987 the lightening hole was eliminated from the Transverse Bulkhead and inspections recommended. After another bulkhead failure this change was made mandatory and written up in the Mustang Newsletter Vol 9 No 3 (May 1993). The bulkhead was changed from .025" 2024-T3 to .032" in the Midget Mustang and changed from .032" to .040" in the Mustang II. In May 2006 a doubler was added to the bulkhead and the update was published in the Vol 16 No 5 issue of the Mustang Newsletter.

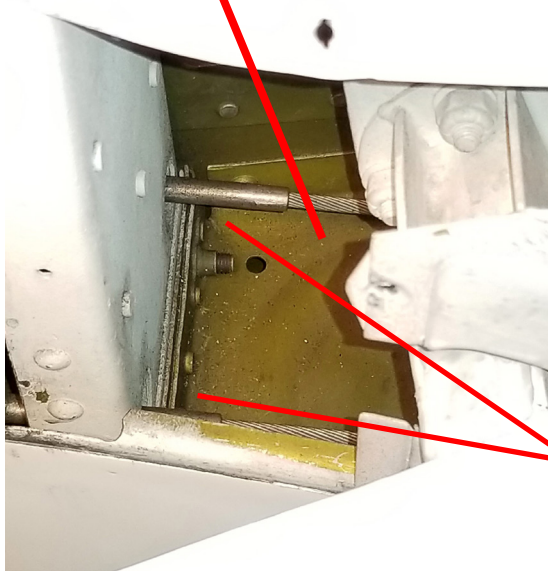
Inspect Corners for Cracks

During the annual airworthiness inspection and more often as needed, the aft transverse bulkhead should be visually inspected by removing both of the aft tailcone covers between the vertical fin and horizontal stabilizer. A close examination of the transverse bulkhead (p/n 240.345 / 140.356) for any cracks and the steel elevator control arms (p/n 250.210 / 150.210) for cracks around the welds is an important part of every airworthiness inspection.

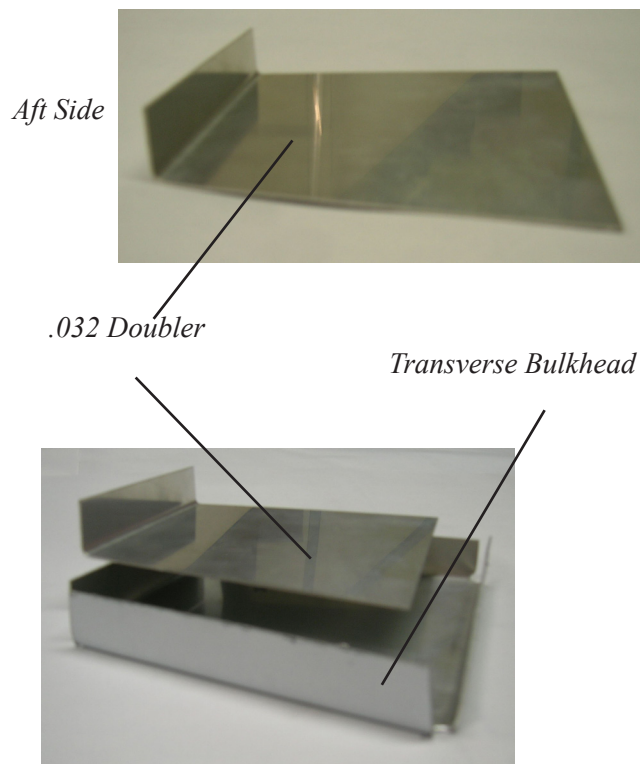
We had a report that a Mustang II had a failure in the Transverse Bulkhead p/n 240.345 although this was probably the result of a missing bolt from the lower fin attach point. In a previous revision this bulkhead had been changed to thicker material and the lightening hole eliminated. This particular airplane has over 1200 hours and does not have this revision. For new airplanes we are adding an additional doubler just as an extra precaution. This is not a mandatory change. A good preflight should include checking the stiffness between the fin and horizontal stabilizer. Excessive movement is an indication that there is a problem.

If you are building a Midget Mustang or do not have the stiffening bead in the bulkhead, the doubler can be attached to the bulkhead without the hole using 1/8" rivets on 7/8" spacing, staggering rows 5/8" apart.

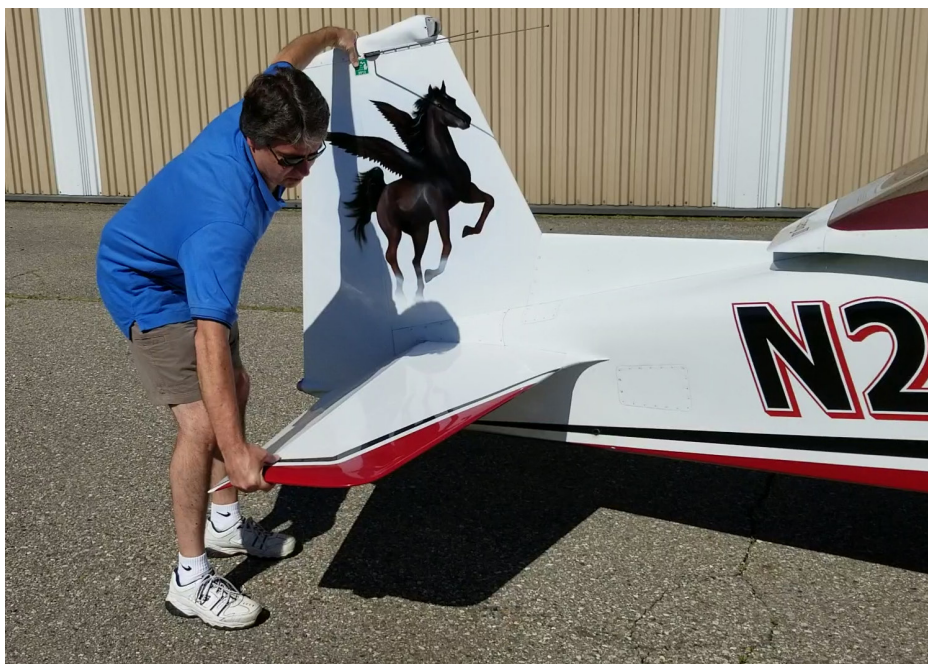
Preflight Inspection Procedures

As a part of **every** preflight inspection in a Midget Mustang or Mustang II the aft transverse bulkhead should be checked for cracks by performing the following procedure:

Holding onto the tip of the vertical fin rear spar (not the fiberglass tip) in one hand and tip of the horizontal stabilizer rear spar in the other (not the fiberglass tip) gently pull them towards each other with a small amount of force. The Midget Mustang will have a slight give as it does not have the front spar carry through in either the vertical fin or horizontal stabilizer. The Mustang II should not have any give between the tail surfaces. The important thing to notice is any change over time. If there is more give than normal remove the aft tailcone inspection cover and examine the aft transverse bulkhead and the fin attach points carefully for any cracks.

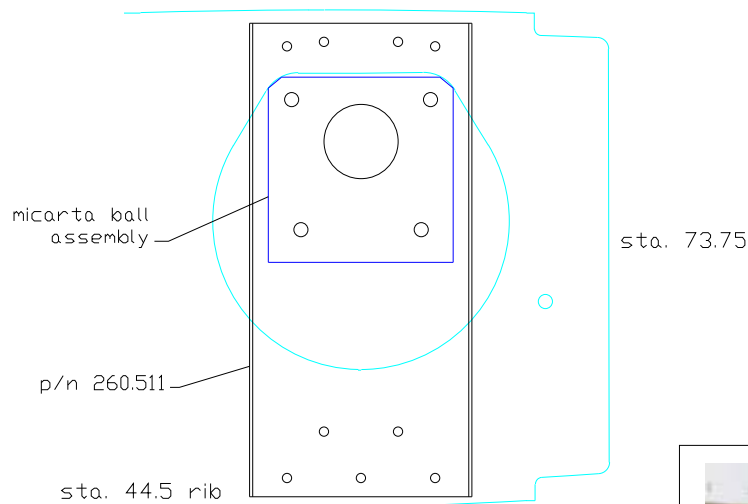
Station 44.5 Rib and Micarta Ball Assy.

The forward edge of the aileron inboard control tube mounting bracket will interfere with the main spar rib attach angle when mounted to the station 44.5 rib as shown in drawing 260.006. The interference can be eliminated by rotating the mounting bracket 90 degrees on the station 44.5 rib as shown below. Detailed drawings are available on the Mustang website for p/n 260.511. This part is now included in the center section kits.

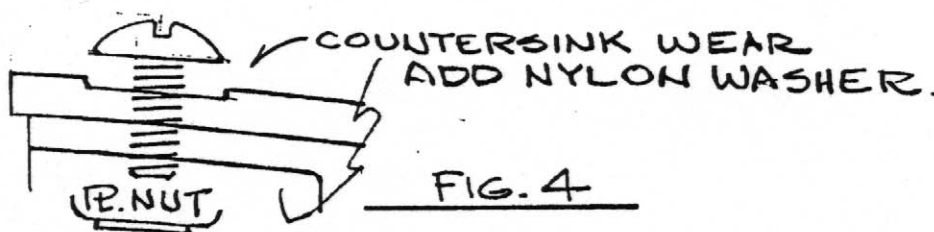
you use a nylon washer under each screw head. The nylon washer acts as a cushion against vibration wear and pressure compensator during temperature changes. If you have not been using these washers and find a black residue under the heads when you remove the screws -- your spinner is wearing away under the heads. Refer to Figure 4.

Your best insurance against wear is the nylon washer. Don't go flying without them. This works for new installations too. For you machinists out there, you can use a dial indicator in lieu of the felt pen (take care not to scratch the spinner).
