# MUSTANG AERONAUTICS, INC.

#### Mustang II & Midget Mustang Service Letter

<u>Date:</u> 7/30/2019

Subject: Inspection of the tailcone transverse bulkhead p/n 240.345 (M-II) or p/n 140.356 (M-I)

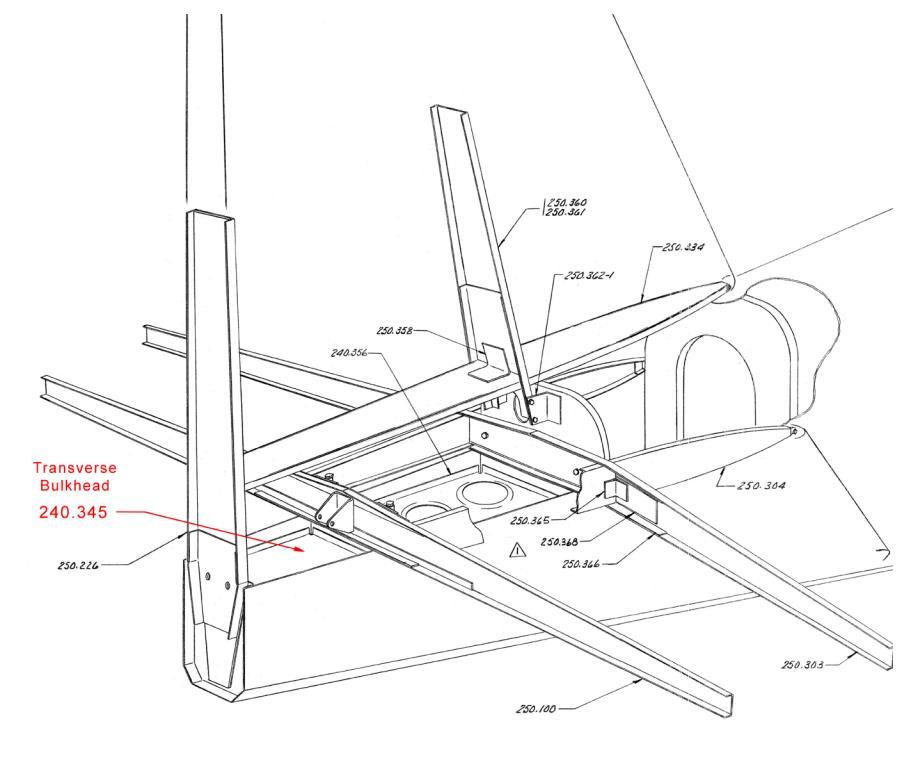
The small Transverse Bulkhead is a critical attach point for the vertical fin as it has 2 of the 3 lower fin rear spar attach points. Refer to construction drawing #29 for the Midget Mustang and drawings 240.021 and 240.023 for the Mustang II.

The affected aircraft suffered a fatigue crack in the transverse bulkhead emanating from the aft two corners whose flange is attached to the sta 209.5 bulkhead in the Mustang II. In the Midget Mustang the affected Transverse Bulkhead flange attaches to the sta. 182 bulkhead. Previously issued updates and repeated inspection recommendations have not always been adhered to. Improper manual ground handling has been the primary cause of the failures that we have seen. The original design is sound if the aircraft is not subjected to unapproved/nonstandard loads.

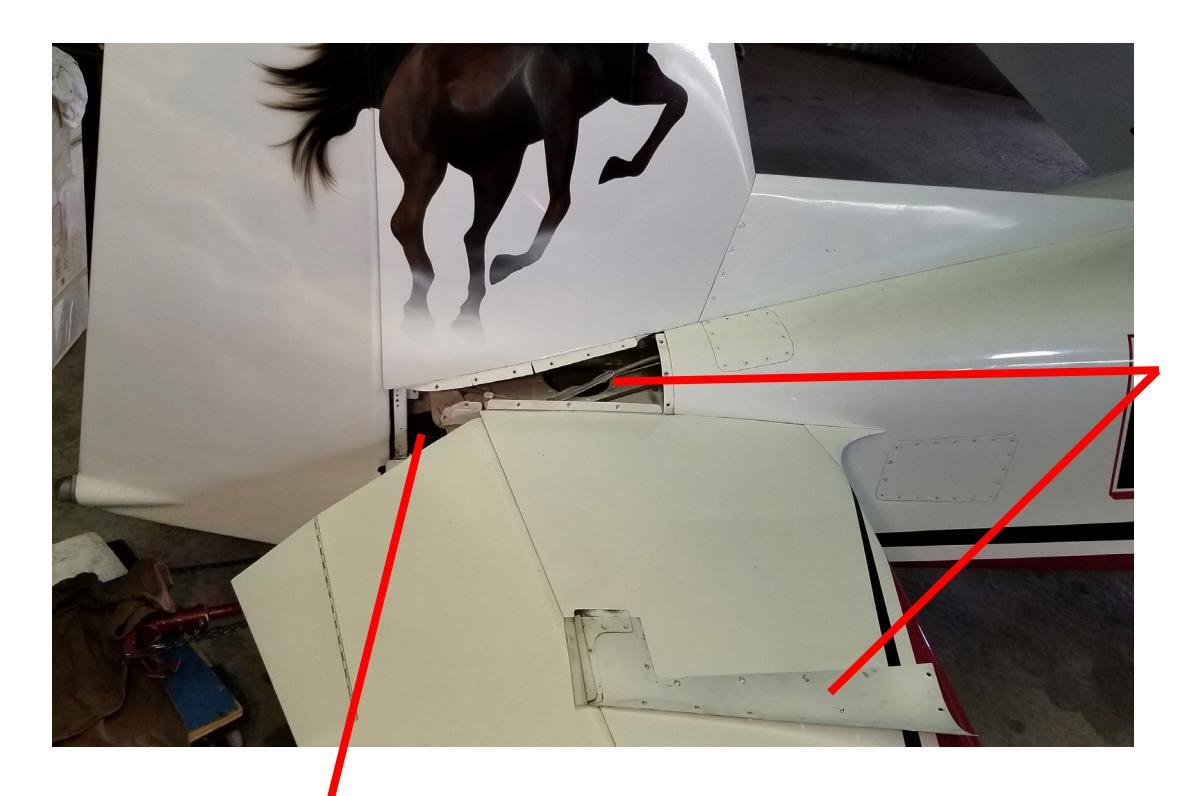
Aft Tailcone Inspection Cover

Transverse Bulkhead

Repeatedly moving the aircraft on the ground by lifting the tail of the airplane by the horizontal stabilizer or applying a side load to the vertical fin can put excessive torsional loads on the Transverse Bulkhead. Mustangs should never be lifted or moved by applying force to the empennage. Instead steer the airplane manually on the ground by pushing on the side of the tailcone at a bulkhead, by lifting the tailwheel and pulling the airplane around by it, or by a tow bar connected to the tailwheel or nose wheel. Snap rolls can also put excessive loads on the transverse bulkhead. If aerobatics are performed in aircraft without the updates the aft tailcone inspection cover should be removed and the transverse bulkhead inspected more than once per year. Snap rolls are not approved in the Mustang II. Proper installation of the 3 AN3 bottom fin rear spar attach bolts is also critical. A transverse bulkhead failure typically leaves only the vertical fin leading edge attach bolt, the single bottom lower fin rear spar attach bolt, and the rudder cables to hold the vertical fin on the aircraft. While a loss of the vertical fin has not occurred, serious structural damage has resulted from the failure of this bulkhead. In June 1987 the light-ening hole was eliminated from the Transverse Bulkhead and inspections recommended. After another bulkhead failure this change was made mandatory and written up in the Mustang Newsletter Vol 9 No 3 (May 1993). The bulkhead was changed from .025" 2024-T3 to .032" in the Midget Mustang and changed from .032" to .040" in the Mustang II. In May 2006 a doubler was added to the bulkhead and the update was published in the Vol 16 No 5 issue of the Mustang Newsletter.

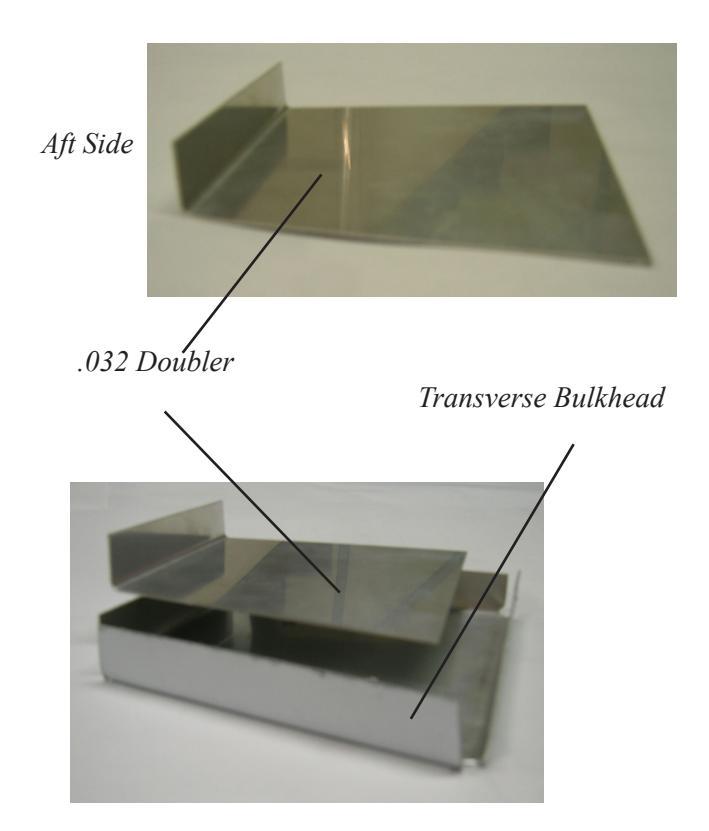
#### **Transverse Bulkhead Doubler**

We had a report that a Mustang II had a failure in the Transverse Bulkhead p/n 240.345 although this was probably the result of a missing bolt from the lower fin attach point. In a previous revision this bulkhead had been changed to thicker material and the lightening hole eliminated. This particular airplane has over 1200 hours and does not have this revision. For new airplanes we are adding an additional doubler just as an extra precaution. This is not a mandatory change. A good preflight should include checking the stiffness between the fin and horizontal stabilizer. Excessive movement is an indication that there is a problem.

For the Mustang II a lightening hole can be cut in the center of the new doubler to allow it to lay flat against the transverse bulkhead. The doubler is riveted to the bulkhead at the corners using 3/32" universal head rivets on 5/8" spacing, staggering rows 1/2" apart.

If you are building a Midget Mustang or do not have the stiffening bead in the bulkhead, the doubler can be attached to the bulkhead without the hole using 1/8" rivets on 7/8" spacing, staggering rows 5/8" apart.
