MIDGET MUSTANG - MODEL M-I

MANUAL REVISIONS

## Mustang II & Midget Mustang Service Letter

Subject: Inspection of the tailcone transverse bulkhead p/n 240.345 (M-II)  
or p/n 140.356 (M-I)

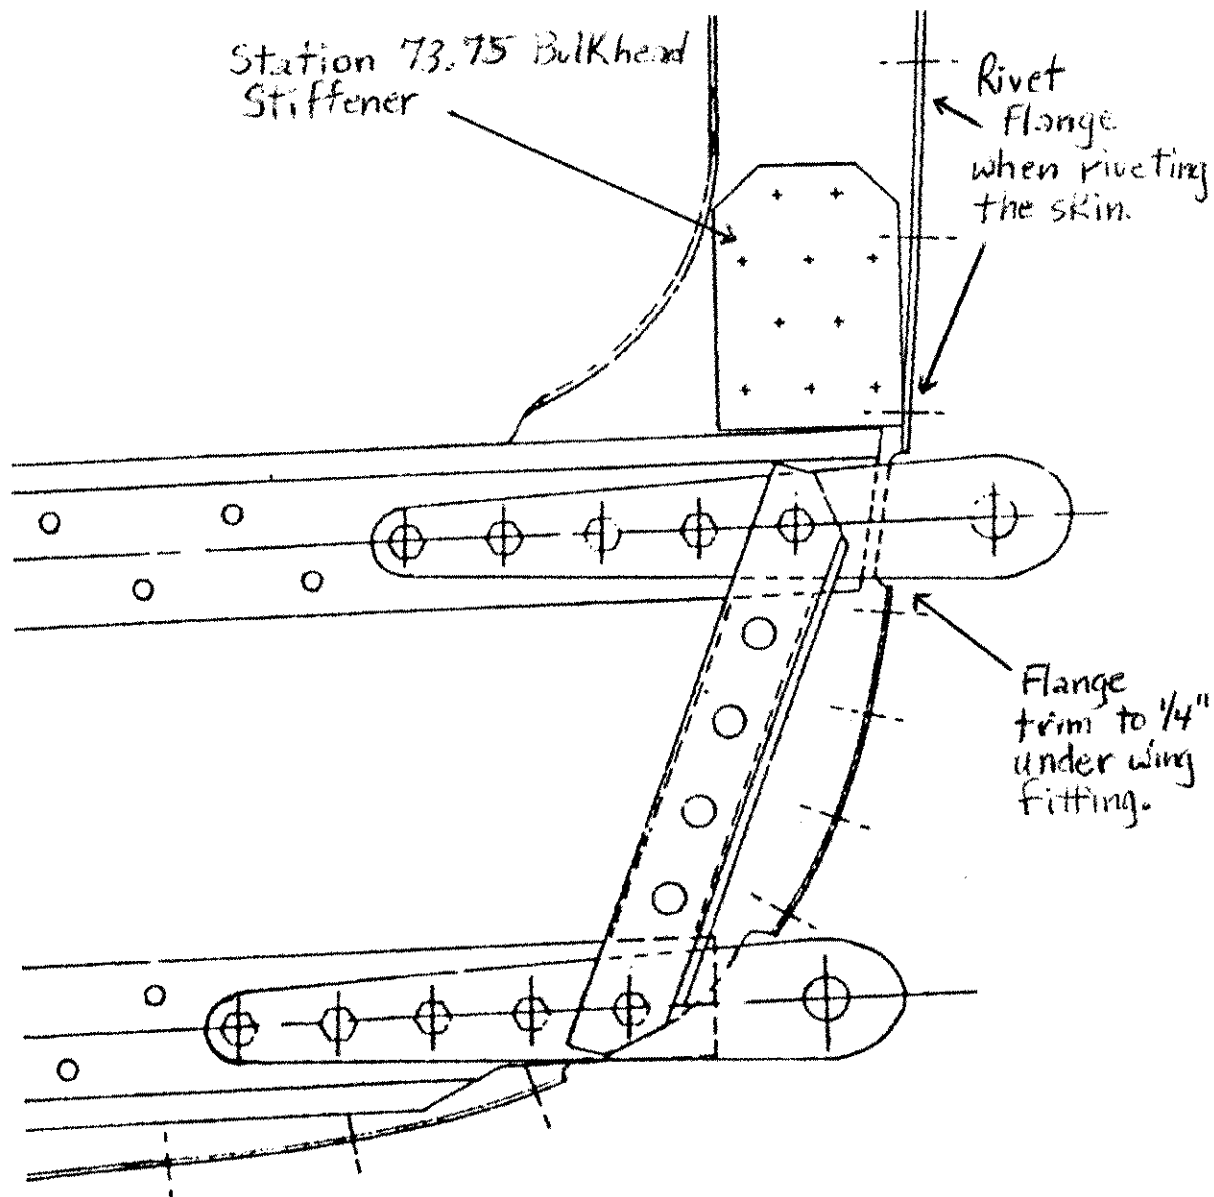
FIGURE #5

There are reports from the field of cracks developing in the station 73.75 bulkhead. The crack starts at the top outboard corner of the angle carry-through member, emanating from the cut out for the wing fitting clearance. Examination of this area may also show a bulge in the bulkhead web. It is suspected that the crack and bulge is caused by high inertial loads created by high "G" landings.

Installation of the doublers shown in the illustration would be a satisfactory repair. Installation of the doublers is recommended for new manufactured Midget Mustangs to prevent future operational difficulties.
