Mustang II Revisions

The following pages contain major design changes to the Mustang II.

Mustang II Revision Changes

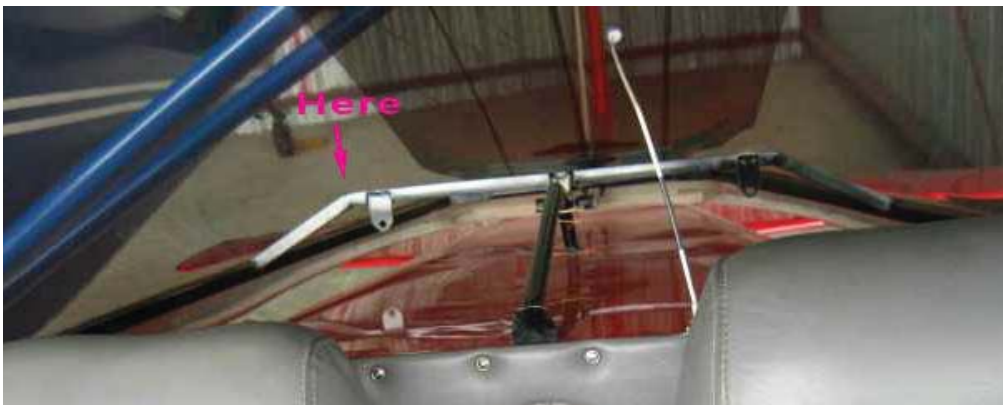
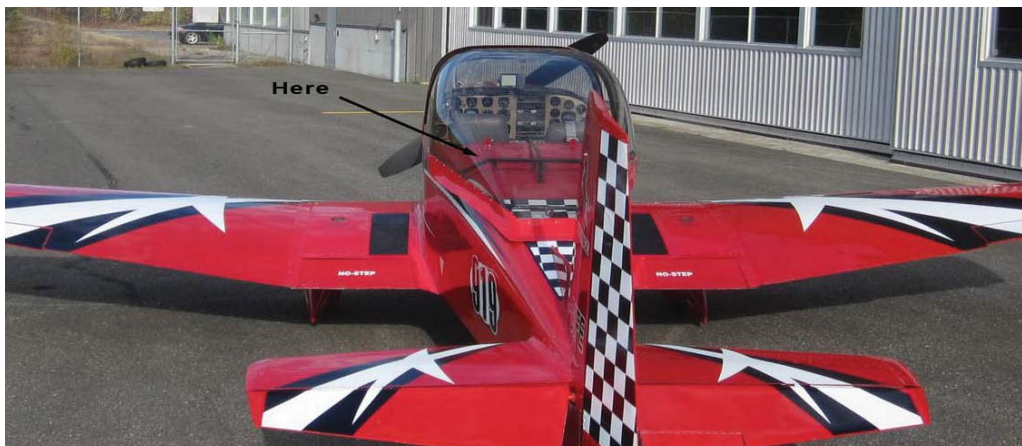
A recent Mustang II canopy failure that resulted in the loss of the aircraft and 2 occupants is a tragic reminder that the canopy is an important part of the annual inspection. Owners should verify that the Canopy Frame Revision from 1984 has been installed and that the rear canopy frame is structurally sound. The canopy latch should also be inspected for function and integrity. The canopy does experience lifting loads that can be fairly substantial.

A Cut and Butt Welded Cross Brace is NOT Acceptable

(possible examples)

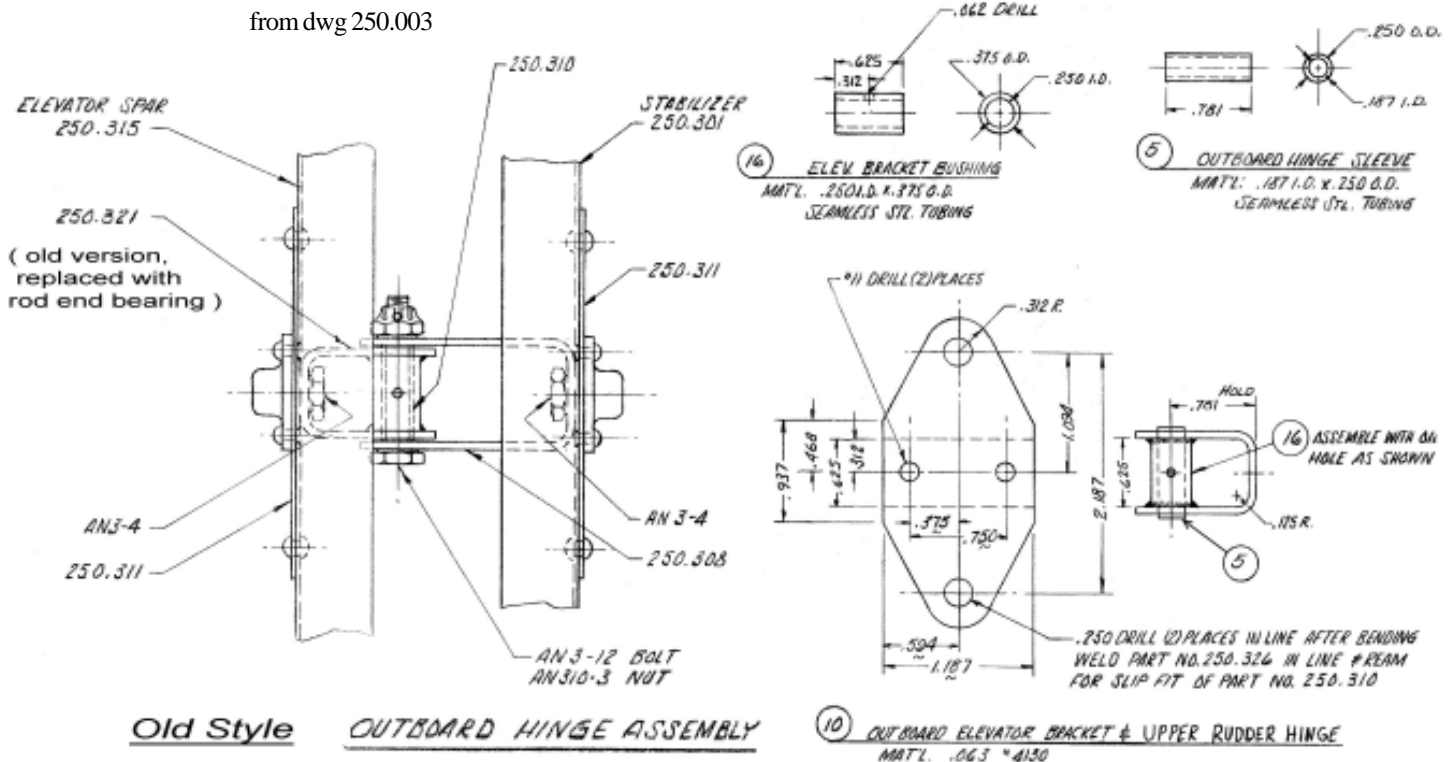
Original Configuration

This change is not required for existing aircraft that do not have hinge alignment issues (binding) of the elevators. It was primarily made to simplify construction and manufacturing. It will also help to eliminate the possibility of cracks in the horizontal stabilizer spar around the doublers at the outer elevator hinge points due to misalignment of the hinge points.

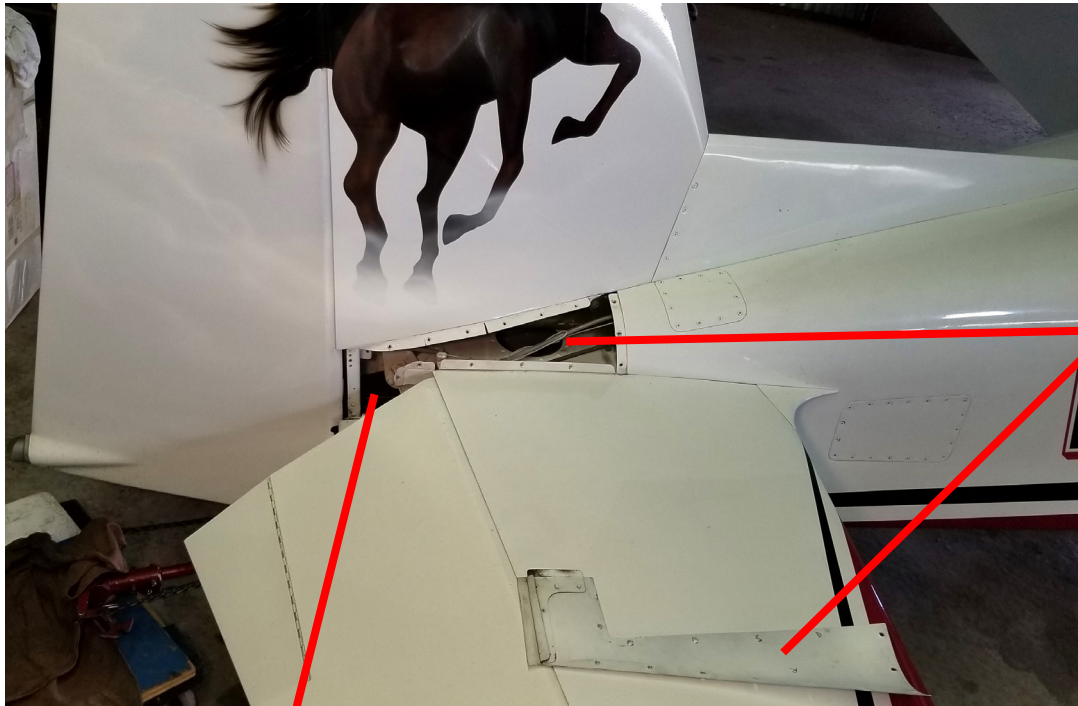
Aft Tailcone
Inspection Cover

We have had another report of a failed Transverse Bulkhead (p/n 240.345) in an older Mustang II. No Mustangs with the design changes to the Transverse Bulkhead in May of 1993 have had cracking issues. The Midget Mustang has a similar design (p/n 140.356) and should follow the same inspection methods. A simple preflight check should reveal a crack in the transverse bulkhead before the aircraft is flown and should be done before every flight of all Mustangs. See page 4 for the preflight inspection procedure.

The affected aircraft suffered a fatigue crack in the transverse bulkhead emanating from the aft two corners whose flange is attached to the sta 209.5 bulkhead in the Mustang II. In the Midget Mustang the affected Transverse Bulkhead flange attaches to the sta. 182 bulkhead. Previously issued updates and repeated inspection recommendations have not always been adhered to. Improper manual ground handling has been the primary cause of the failures that we have seen. The original design is sound if the aircraft is not subjected to unapproved/nonstandard loads.

Repeatedly moving the aircraft on the ground by lifting the tail of the airplane by the horizontal stabilizer or applying a side load to the vertical fin can put excessive torsional loads on the Transverse Bulkhead. Mustangs should never be lifted or moved by applying force to the empennage. Instead steer the airplane manually on the ground by pushing on the side of the tailcone at a bulkhead, by lifting the tailwheel and pulling the airplane around by it, or by a tow bar connected to the tailwheel or nose wheel. Snap rolls can also put excessive loads on the transverse bulkhead. If aerobatics are performed in aircraft without the updates the aft tailcone inspection cover should be removed and the transverse bulkhead inspected more than once per year. Snap rolls are not approved in the Mustang II. Proper installation of the 3 AN3 bottom fin rear spar attach bolts is also critical.

A transverse bulkhead failure typically leaves only the vertical fin leading edge attach bolt, the single bottom lower fin rear spar attach bolt, and the rudder cables to hold the vertical fin on the aircraft. While a loss of the vertical fin has not occurred, serious structural damage has resulted from the failure of this bulkhead. In June 1987 the lightening hole was eliminated from the Transverse Bulkhead and inspections recommended. After another bulkhead failure this change was made mandatory and written up in the Mustang Newsletter Vol 9 No 3 (May 1993). The bulkhead was changed from .025" 2024-T3 to .032" in the Midget Mustang and changed from .032" to .040" in the Mustang II. In May 2006 a doubler was added to the bulkhead and the update was published in the Vol 16 No 5 issue of the Mustang Newsletter.

Inspect Corners for Cracks

As a part of **every** preflight inspection in a Midget Mustang or Mustang II the aft transverse bulkhead should be checked for cracks by performing the following procedure:

During the annual airworthiness inspection and more often as needed, the aft transverse bulkhead should be visually inspected by removing both of the aft tailcone covers between the vertical fin and horizontal stabilizer. A close examination of the transverse bulkhead (p/n 240.345 / 140.356) for any cracks and the steel elevator control arms (p/n 250.210 / 150.210) for cracks around the welds is an important part of every airworthiness inspection.

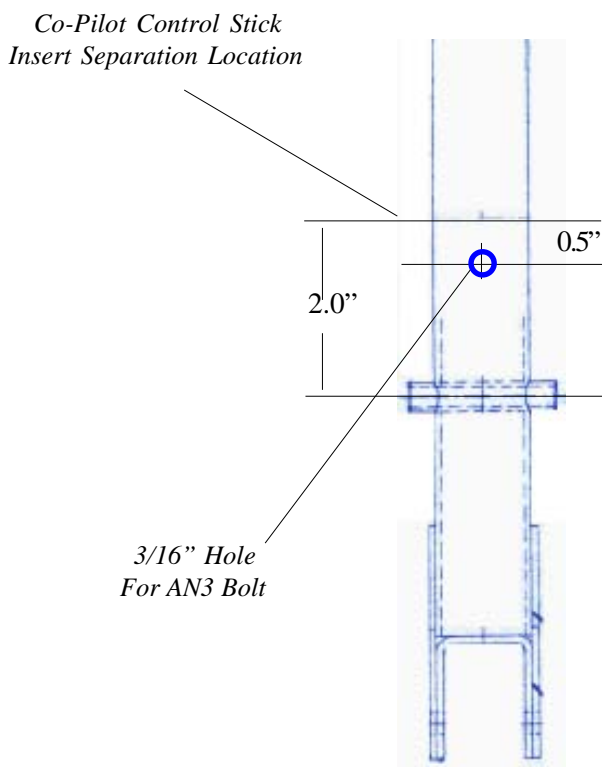
It has been reported that a similar homebuilt design aircraft made a hard landing when the co-pilot accidentally pulled the passenger side control stick from the assembly while landing the airplane. The co-pilot control sticks provided in the Mustang II kits have removable top sections. Removable control sticks are to be pinned or bolted while the aircraft is in use.

The co-pilot control stick in the kit is cut 2" above the control stick bushing with a tube insert welded inside the top portion of the stick so it can be slipped in place and pinned. It is up to the builder to drill the pin or bolt hole approximately 1/2" below the point of separation. Some builders have also modified the pilot stick this way to make working under the instrument panel much easier. The removable portion of the stick has to be bolted in place if this is done.

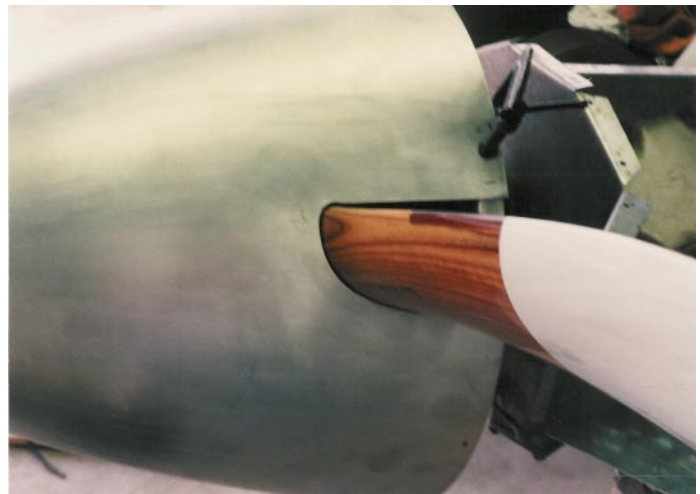
The prop cut outs in the spinner are where most cracking problems occur. This is why it should be reinforced with a doubler riveted to the inside. These spinners are much heavier than those supplied in the past and are therefore much less susceptible to cracking. However, we do still recommend installing an .040 doubler around the cut out. The doublers need to stop short of where the backplate fits on the inside edge of the dome. It is very important that the edges around the cut outs be polished to remove all nicks and other possible stress risers. We recommend using emery paper followed by Scotch Brite for a final finish.

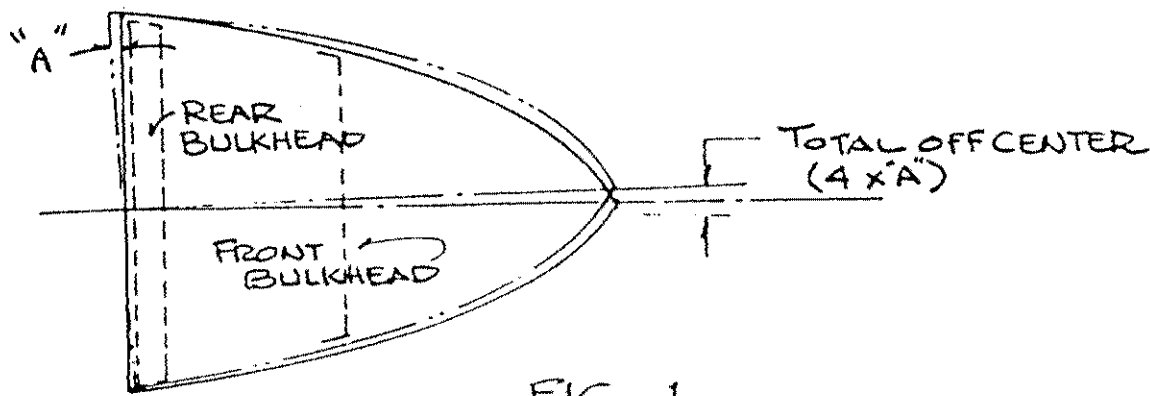
You might think this is not possible with just a few thousandths in the holes and that tight-fitting front hub bulkhead. Wrong! It is a fact. Aluminum as you know by now has "give" and "spring back", so you can push the spinner on tight and off center. Figure 1 illustrates how a few thousandths can give an off center line condition. Mustangs have large spinners so the multiplication factor is also large.

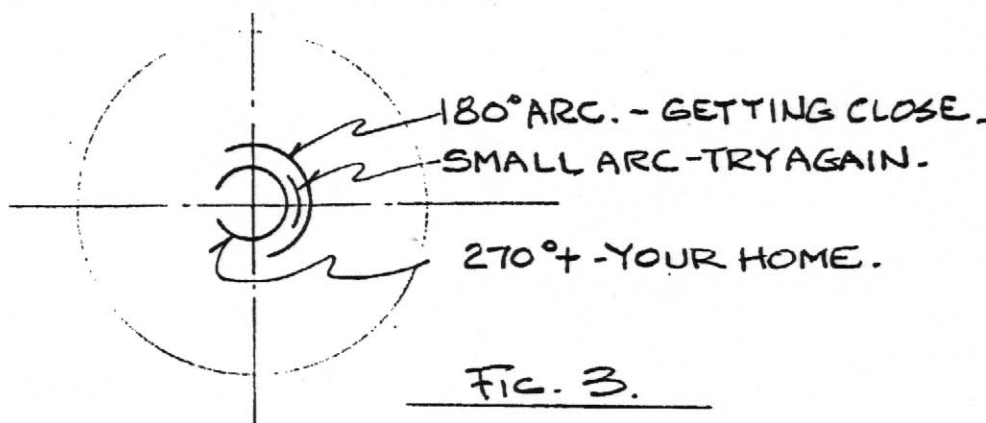
Several tries will be required. When you get an arc of 270 degrees or more, your spinner is within a few thousandths of center. Refer to Figure 3.

Slowly, so that you do not apply incorrect pressures that permit the engine to move on the motor mounts, turn the prop. At least four of the screws at 90 degree intervals should be "slightly" snug. The marker will trace a path on the spinner. If you get an arc of 180 degrees or less, adjust the spinner by a slight "rap" of your palm in the appropriate direction. Do not wipe away the trace, but move the marker to say, 7/8" or 1-1/8" from the tip. Rotate the spinner again and note the trace. If unchanged, your screws are snugged too tight or your "rap" was too light.

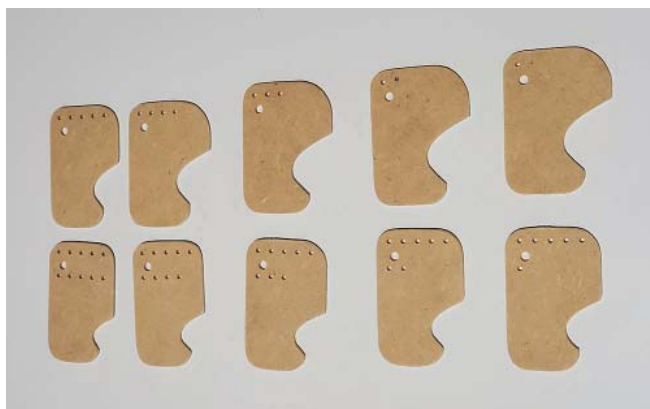
Wing Leading Edge Radius Template Set
p/n 230.0009

The airfoil used on both the Midget Mustang and Mustang II is a fairly thin laminar flow airfoil. It is optimized to reduce drag. The maximum thickness at the root is about 6 inches and the maximum thickness at the tip is 3 inches. Fabricating the leading edge skins by hand can take some work to get the proper airfoil shape at the leading edge. This is critical for proper stall speeds and characteristics. In the kits now supplied by Mustang Aeronautics leading edge skins are supplied which have the proper leading edge radius formed into them. Many older Mustangs have wings that were fabricated entirely by the builder. On these scratch built Mustangs the leading edge skins were made by hand and the leading edge radius is sometimes too small (or sharp). This is because when the skins were folded over and flattened to get the desired airfoil thickness most of the bending occurs in a very small section at the leading edge. Some follow up work is required to achieve the proper airfoil shape and thus the proper flight characteristics. Robert Bushby published an article in the January 1991 issue of the Mustang Newsletter detailing the procedures to fine tune the wing leading edge shape to get the best stall characteristics. We have heard from builders in the field that they have reduced their stall speeds by 15 mph using this technique. A Mustang with a stall speed over 65mph at our recommended gross weights almost certainly has the wrong leading edge shape.

Wing leading edge radius templates can be made from the wing rib drawing or purchased from Mustang Aeronautics (p/n 230.0009). These can be used to check the wing at each rib location for the proper leading edge radius and to verify that both wings are the same. Keep in mind that the intermediate wing ribs do not have a full nose section and stop about 7/16" short of the leading edge so it is fairly easy to reshape the leading edge. The procedures detailed in the following article by Robert Bushby can be used to correct the wing leading edge shape and improve the stall characteristics.
