MUSTANG AERONAUTICS, INC.

Mustang II & Midget Mustang Service Letter

Date: June 8, 2020 rev March 24,2021

Subject: Stall Speed and Wing Leading Edge Shape

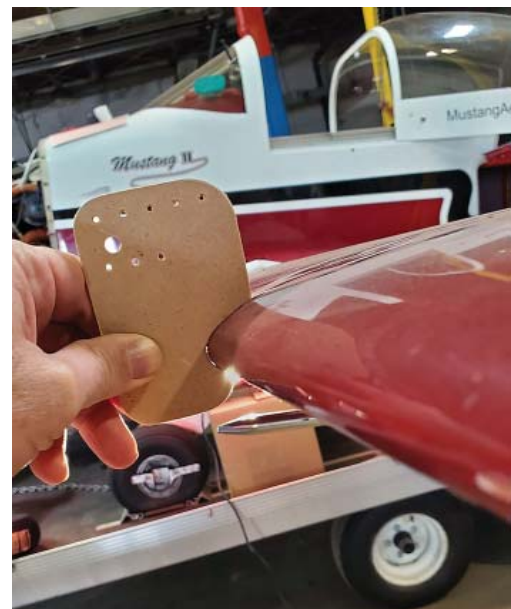
Wing Leading Edge Radius Template Set
p/n 230.0009

Wing leading edge radius templates can be made from the wing rib drawing or purchased from Mustang Aeronautics (p/n 230.0009). These can be used to check the wing at each rib location for the proper leading edge radius and to verify that both wings are the same. Keep in mind that the intermediate wing ribs do not have a full nose section and stop about 7/16" short of the leading edge so it is fairly easy to reshape the leading edge. The procedures detailed in the following article by Robert Bushby can be used to correct the wing leading edge shape and improve the stall characteristics.
